UNITED STATES AIR FORCE IERA

Preliminary Health Risk Assessment, Vladivostok Humanitarian Assistance Ecology Project

August 2000

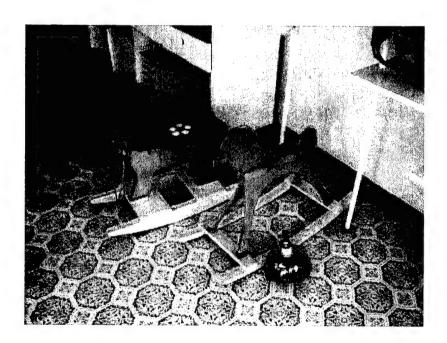
Figure 2. Yellow Rocking Horses at School 141.

The yellow paint shown (sample V99C5456) tested positive for lead at a level of 3.3 mg/cm². In addition, a dust wipe sample (V99D3040) was collected from the horse to see if lead could be "picked up" from normal contact with the play toy. The sample tested positive for lead at 42 $\mu g/100~cm^2$. Although the level of lead in the swipe sample may not be significant (i.e., does not exceed a standard), it does demonstrate that lead can be "picked up" from contact with the toy.

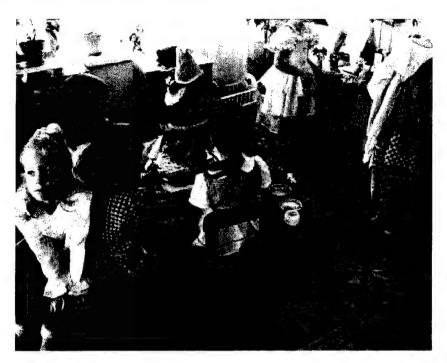
Figure 3 shows a table (sample V99C552) located in the 5-year old playroom where the paint tested positive for lead at a level of 4.2 mg/cm².

Figure 3. Orange Table at School 141.

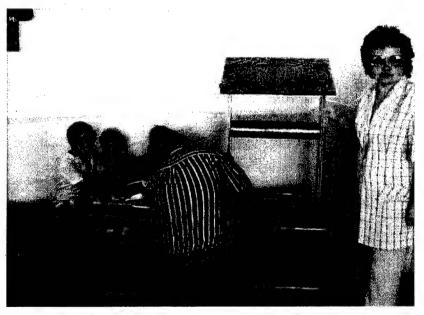
Figure 4 shows a bench also located in the 5-year old playroom. The bench (sample V99C5528) exhibited a lead concentration exceeding 5 mg/cm². Although the Niton XRF reading indicated that the lead was present below the surface, only the yellow color could be seen.

Figure 4. Yellow Bench at School 141.

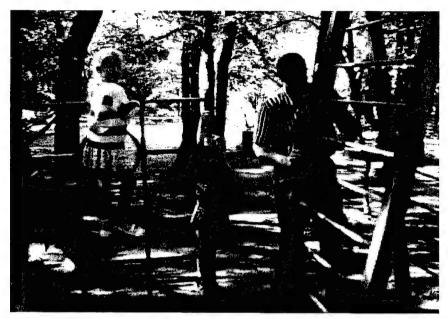
Figure 5 shows a multicolored playground ladder at School 141. The yellow painted surface (sample V99C5505) tested positive for lead at a level of 4.1 mg/cm². The Niton XRF suggested the lead was present 2 layers deep but only the yellow paint was observed in the worn areas.

Figure 5. Multicolored Playground Ladder at School 141.

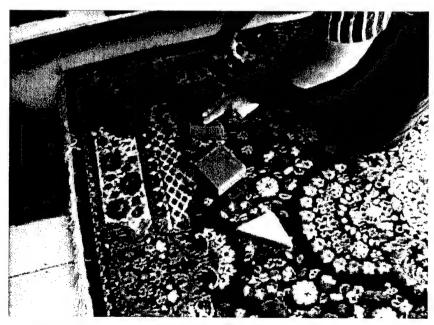
Figure 6 shows the typical multicolored blocks found at all schools. Table 13 shows the breakout of lead content by color. The yellow and green blocks were the colors that most often contained lead of the seven different colors tested. Although green blocks had the highest percentage of blocks with lead concentrations exceeding 1 mg/cm², trace amounts (.1 to .99 mg/cm²) of lead was found in 57 percent of the yellow blocks. School personnel were shown the blocks anytime lead levels were found that exceeded 1 mg/cm².

Figure 6. Typical Multicolored Blocks at All Schools.

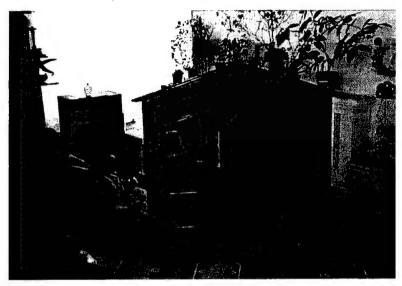
Figure 7 shows a yellow playhouse at School 109. The yellow paint on the toy house (sample V99C5316) had a lead concentration of 1.3 mg/cm². The house was located in the 5-6 year old playroom. In the same room there were yellow shelves (sample V99C5317) that showed a lead concentration exceeding 5 mg/cm².

Figure 7. Yellow Playhouse at School 109

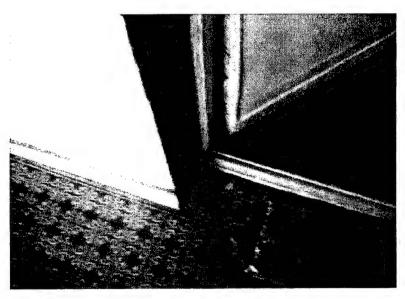
Figure 8 shows a tan door jam at School 113. The tan paint on the door jam (sample V99C5004) exhibited a lead concentration of 1.2 mg/cm². The Niton XRF indicated that the lead was located below the surface but no other color of paint could be identified. The door jam was freshly painted. Door jams are of special interest because of the wear the paint receives by opening and closing doors and people walking across them. Over time the paint will wear creating a fine dust. If lead is present it can then be easily transported.

Figure 8. Tan Door Jam at School

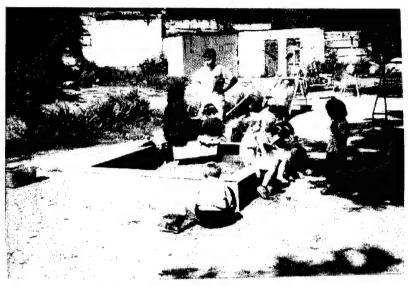
Figure 9 shows a sandbox at School 132. The yellow sandbox (sample V99C5251) tested positive for lead with a concentration of 4.1 mg/cm². As can be seen the box is used often and children come in direct contact with the lead containing paint. A soil sample (V99S2041) from a sandbox located at School 132 exhibited a lead concentration of 68 mg/kg. Also of note are the toy giraffes located in the background of the photo. See Figure 10 for a close-up.

Figure 9. Sandbox at School 132.

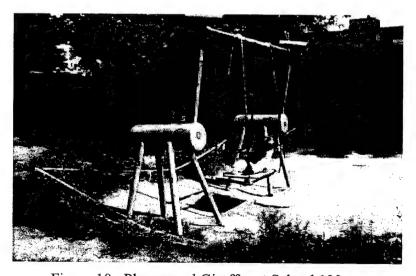
These types of toy giraffes were found at most of the kindergartens and were typically painted yellow. The yellow paint (sample V99C5240) shown tested positive for lead at a concentration exceeding 5 mg/cm². Children were observed climbing and playing on the giraffes and although the equipment was well maintained, the paint was peeling and flaking off. Samples (V99C2300 and 2301) of the flaking paint were collected from a giraffe at School 109 and brought back to the laboratory to confirm the high readings obtained from the Niton XRFs. These samples exhibited very high levels of lead exceeding 25,344 mg/kg. Play items such as these where the children come in contact often and the paint wears easily may represent a significant source of lead.

Figure 10. Playground Giraffes at School 132.
